STRUCTURAL INSPECTION REPORT

201 WATER STREET
FORWARDERS' MUSEUM AND VISITORS INFORMATION CENTRE
TOWN OF PRESCOTT

Date: November 2013
GENIVAR No.: 131-20617-00

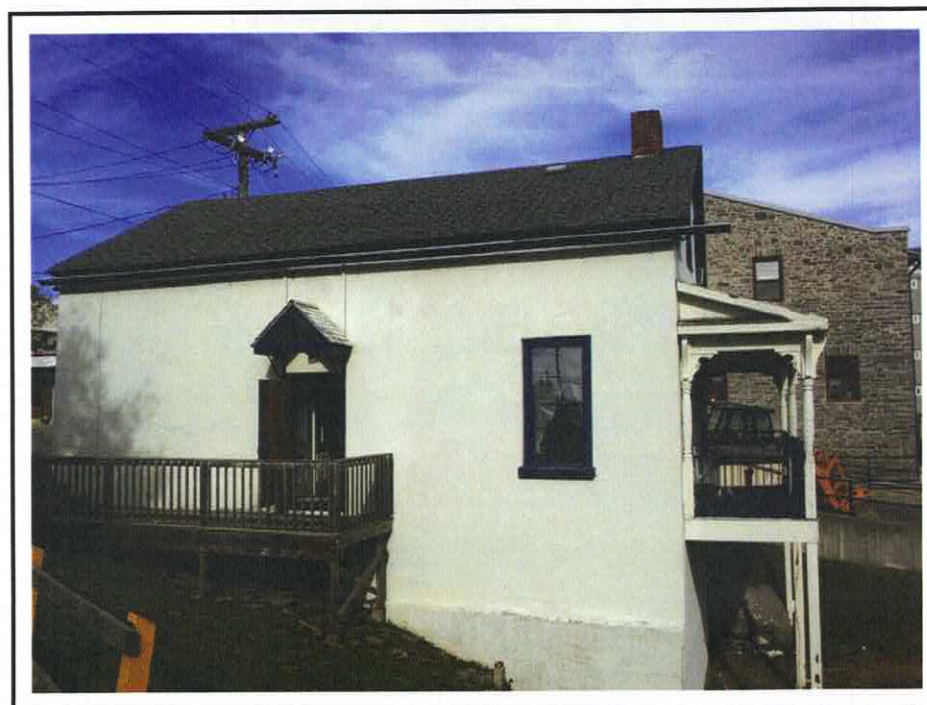
- The asphalt shingles are also in poor condition and are weathered and curling upwards. Despite this no water damage was noted in the 2nd floor. (Photo 2)

Photo 2 West Wall

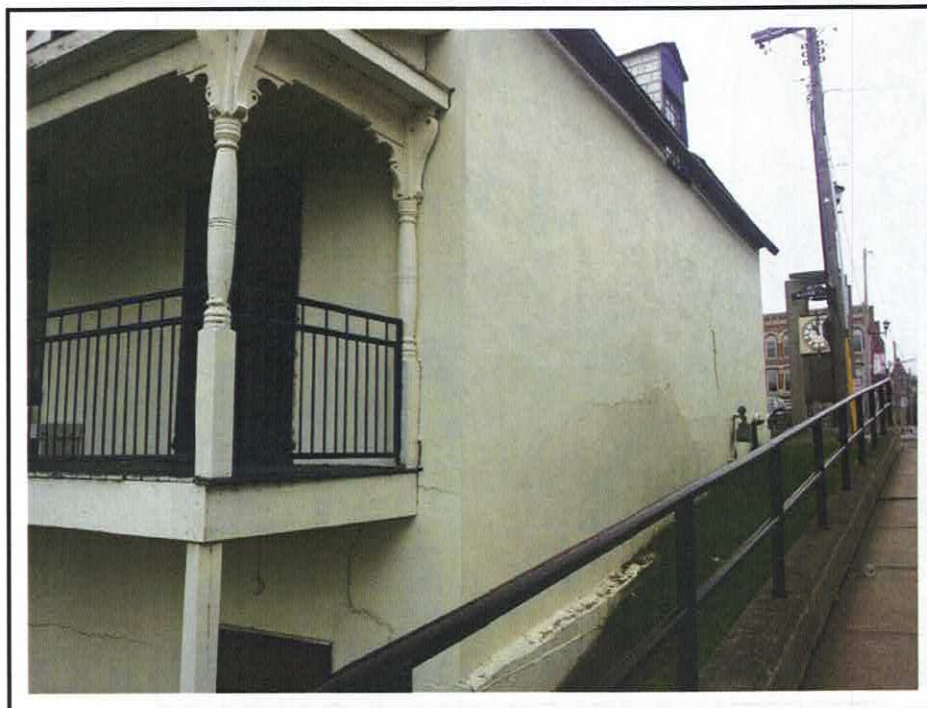
- The timber balcony at the rear of the building was generally in fair condition and exhibited moderate weathering throughout. The bottoms of the columns supporting the balcony exhibited severe rot and section loss where they bear on concrete piers. Gaps in the parging/stucco finish were noted where balcony members are tied into the building. (Photo 4)

Photo 4 East Wall

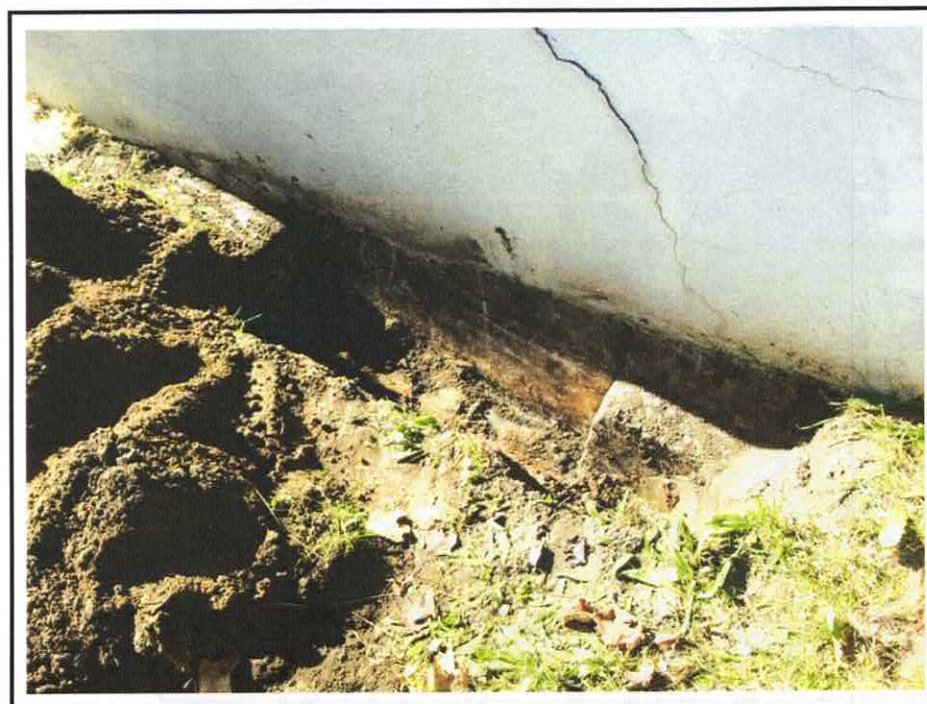
- The south ends of the east and west walls have been strengthened with concrete cast against the exterior of these walls. These repairs extend approximately 6.25m from the south wall of the structure. (Photo 5)
- Above grade the walls have been coated with a parging that is reinforced with wire mesh. This parging is finished with stucco and painted. This finish terminates approximately 900mm below grade.
- Cracking has appeared in the parging/stucco, mainly along the east and south walls. Along the south wall a horizontal crack has developed the full width of the wall and along the east wall random cracking was noted throughout. Localized cracking was also noted at the north end of the west wall. (Photo 6)

Photo 5 Foundation Reinforcement at East Wall

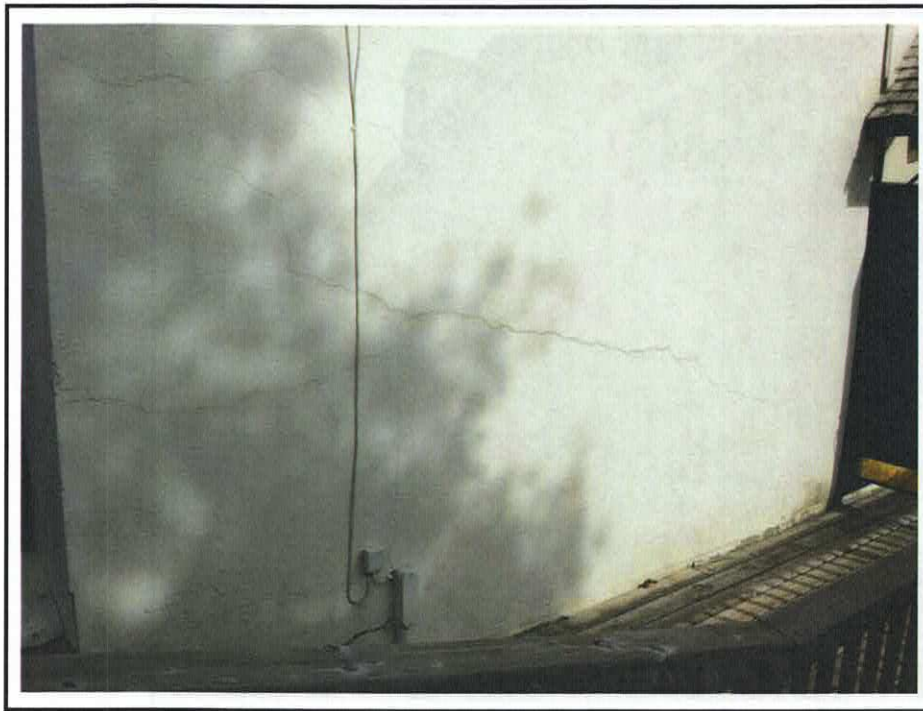
Photo 6 Cracking at North End of West Wall

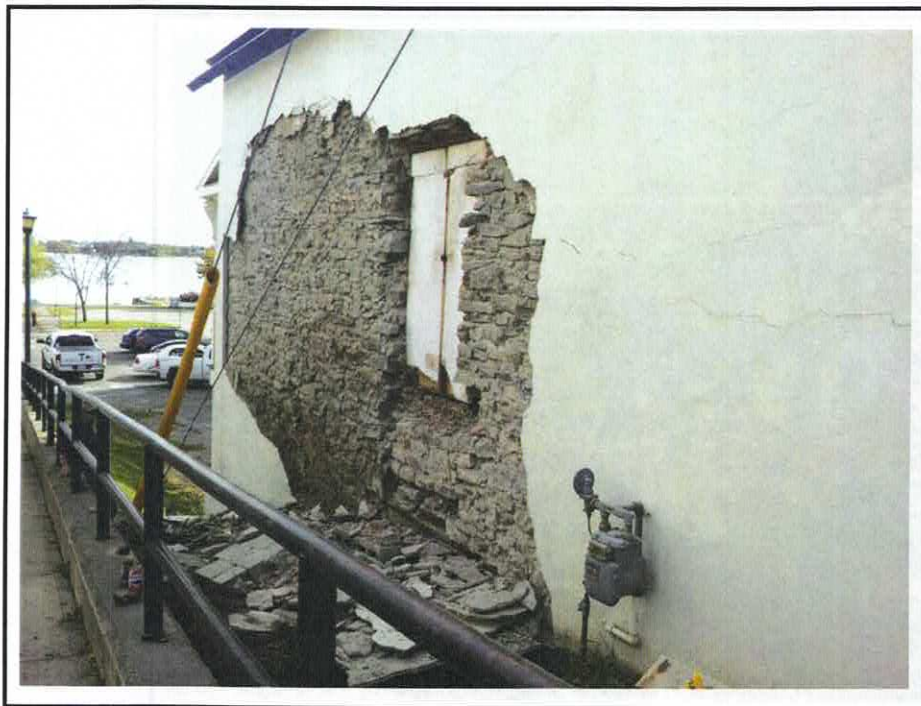
- At the locations of the cracking along the east wall the parging had bulged outwards and was in danger of falling. When parts of the parging were removed it was found that the concrete block had been used to close off an old window. The brick sill that the block had been placed on had disintegrated causing the block to damage the parging and stucco. The block and the remaining loose stucco were removed to eliminate the hazard to the public.

Photo 7 Removal of Stucco/Parging on East Wall

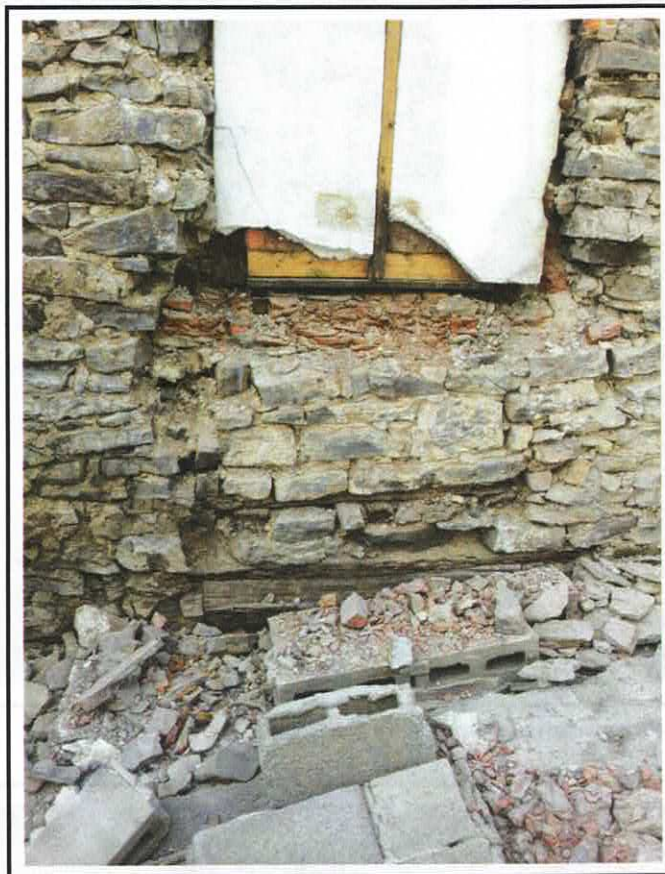
Photo 8

- Where the stucco was removed on the east wall the rubble masonry beneath is generally in poor condition. The surface of the walls is uneven, the size of masonry units and joints are irregular and most of the mortar is severely deteriorated or missing entirely. Throughout the wall numerous masonry units were cracked. The brick sills at the windows have completely disintegrated and numerous masonry units around the windows are missing entirely. The wooden lintels embedded in the walls were in poor conditions and exhibit rot and weathering. (Photo 8)

**Deteriorated Masonry and
Deteriorated Timber Embedded in
Masonry Wall**

- Full excavation of the foundation on all 4 sides.
- Careful removal of the existing stucco and parging from both the interior and exterior.
- Reconstruction of the outer wythe of walls full height.
- Repair and repointing of the inner wythe of walls.

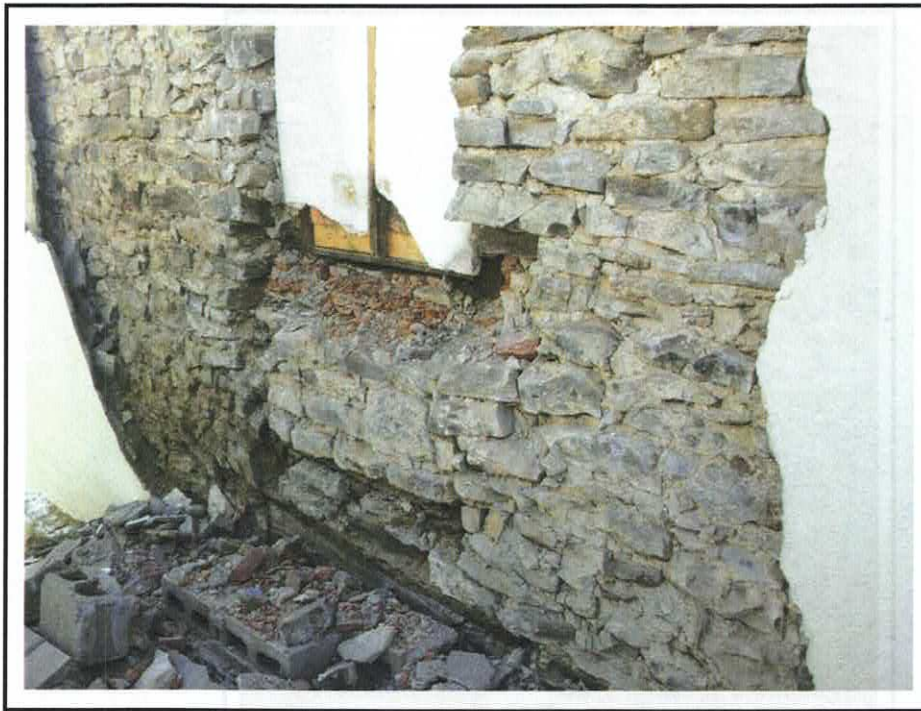
Photo 9 Deterioration at Window in East Wall

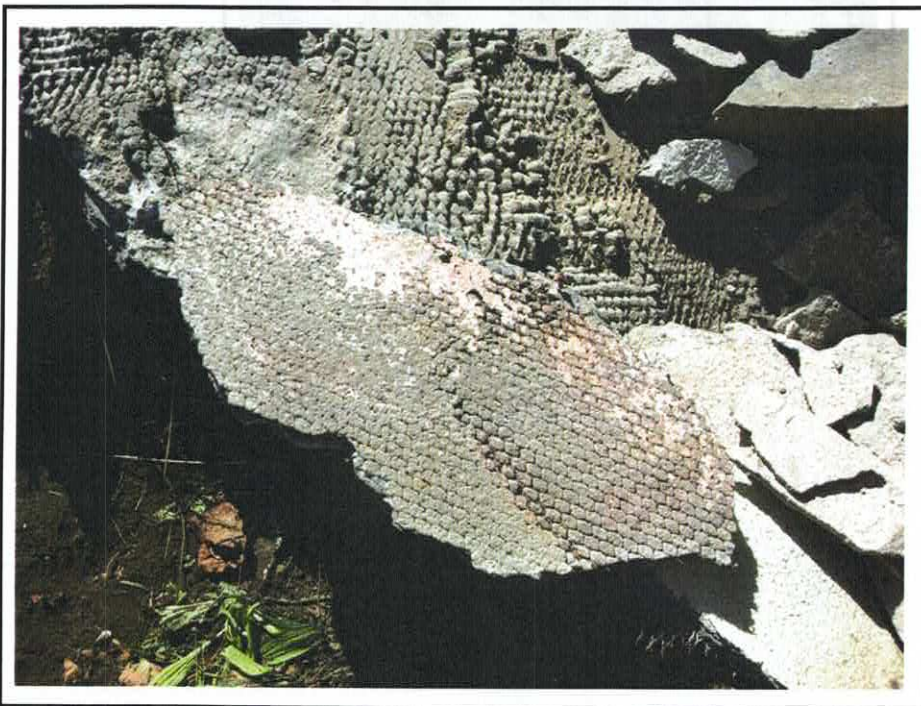
Photo 10 Piece of Parging Removed from Exterior of Building

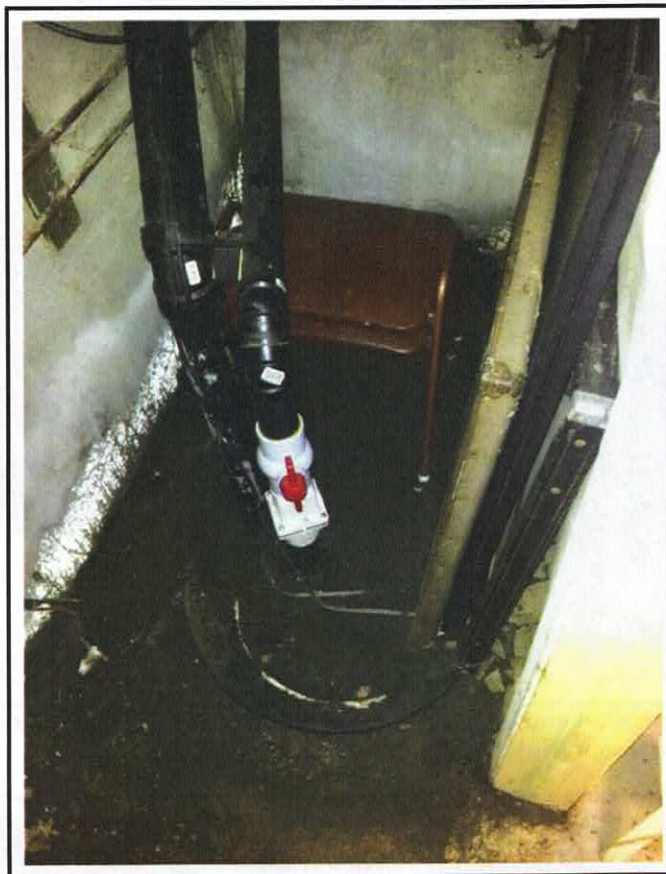
Photo 12

- Dampness and water accumulation was noted in the utility room and staining was noted all along the base of the north exterior wall. (Photo 12)
- Finishes were removed at the base of the north wall in the bathroom in the northeast corner of the basement. In this area large amounts of damp sand were discovered behind the finishes. It was not possible to access or determine the condition of the masonry wall behind but the presence of the sand may indicate deterioration of the masonry. (Photo 13)

Dampness and Staining in Utility Room

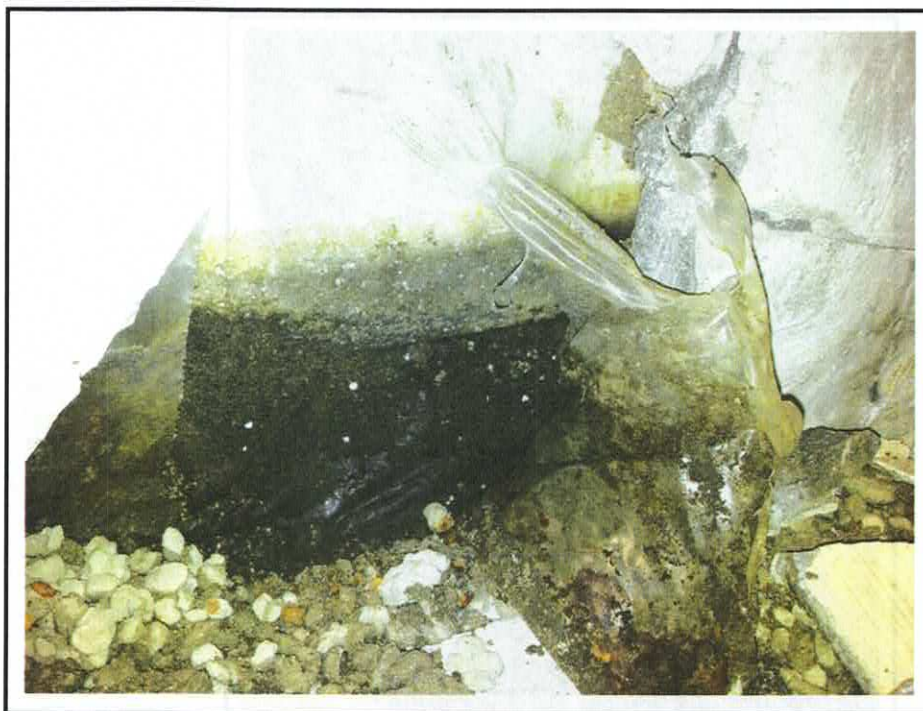
Photo 13 Insulation and Vapor Barrier where Finishes Removed in Basement (Note: staining and dampness)

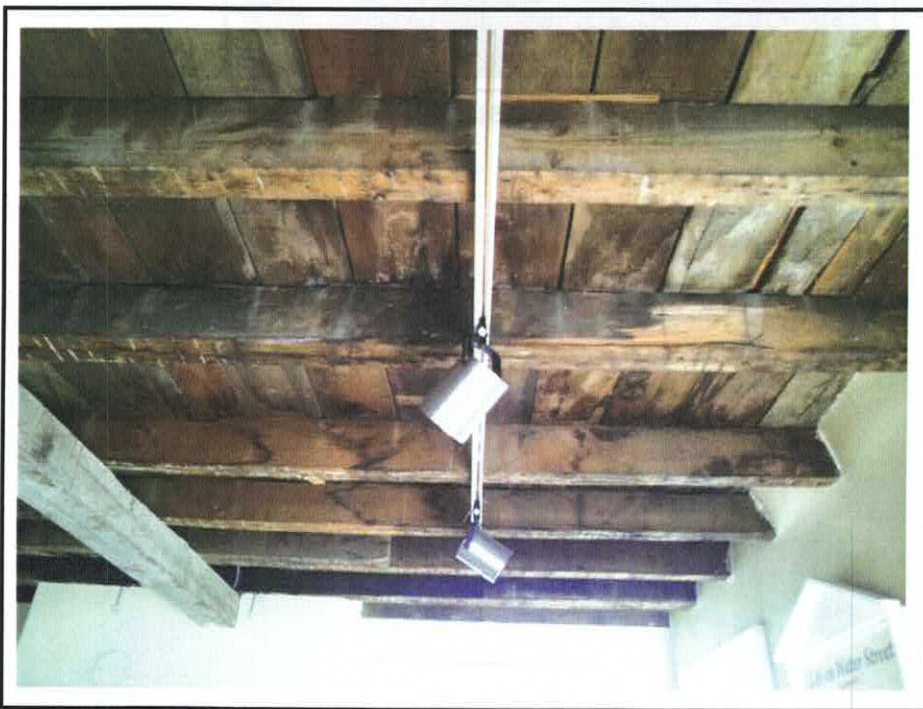
Photo 14 Exposed Beams in Ceiling of First Floor

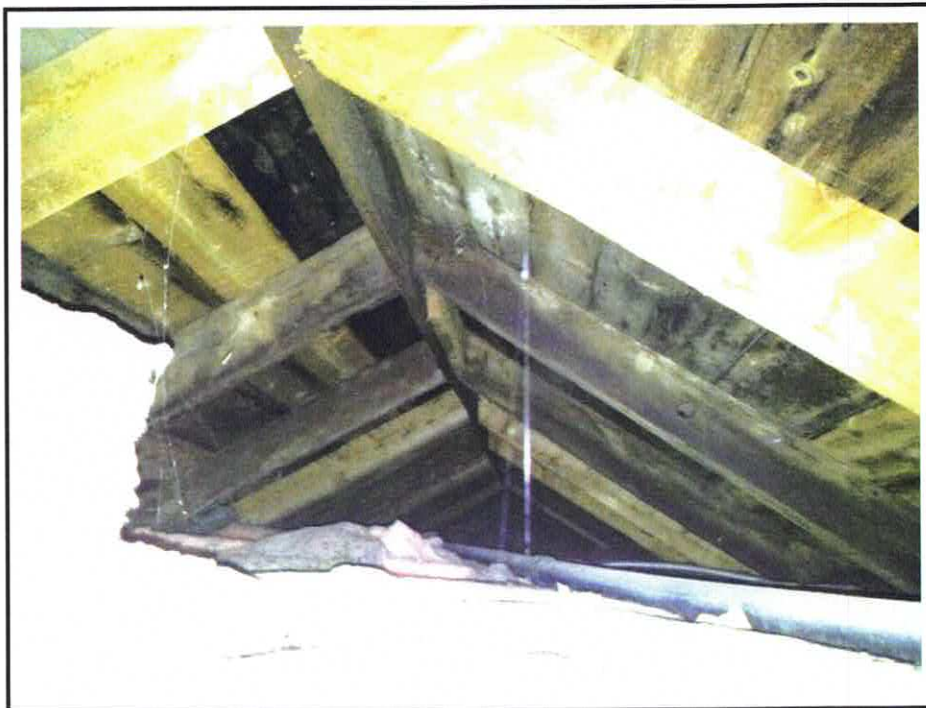
Photo 15 Attic Above Ties
