**STONE MASONRY WALL
STRUCTURAL REVIEW
OF
FORWARDERS' MUSEUM
PRESCOTT, ONTARIO**

REPORT PREPARED FOR
Mr. Dan Beattie
Town of Prescott
360 Dibble Street West
Prescott, Ontario
K0E 1T0

OTTAWA, ONTARIO
July 19, 2018

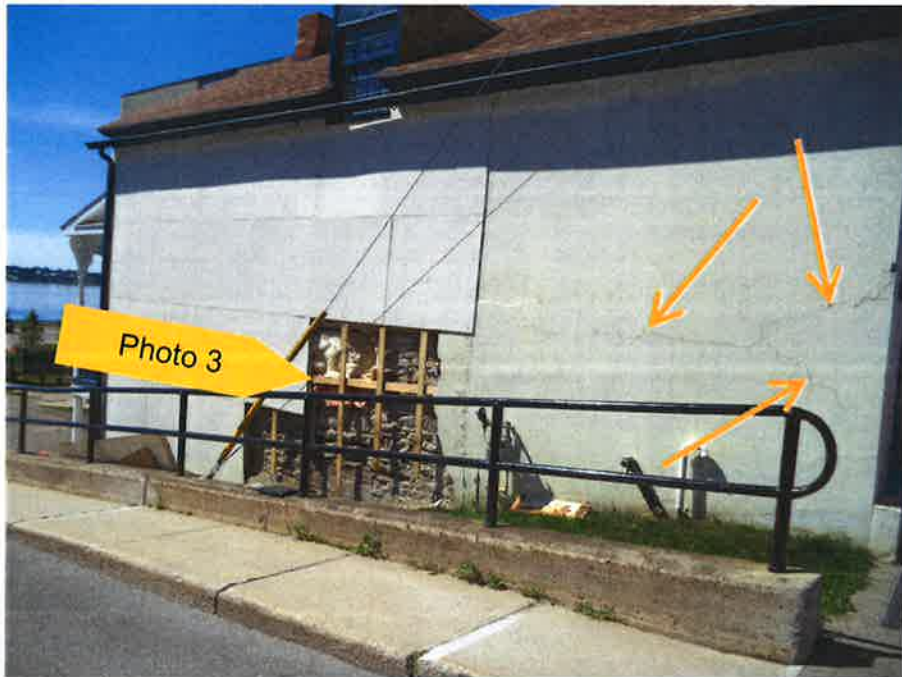
Much cracking was visible in the stucco on the east and west walls (Photo 2) of the building and there is a horizontal crack in the stucco on the south wall (Photos 13 & 14). Other more minor cracks in the stucco were present throughout (Photo 10).

The cracking pattern in the stucco would seem to indicate that some differential foundation movements are occurring between the front and the back of the building, whereas the horizontal crack on the south wall (Photo 13) would indicate bulging of this wall, although it is highly likely that only the stucco is bulging.

2 East elevation showing plywood panels installed over stucco at previous inspection openings. Note cracking in stucco.

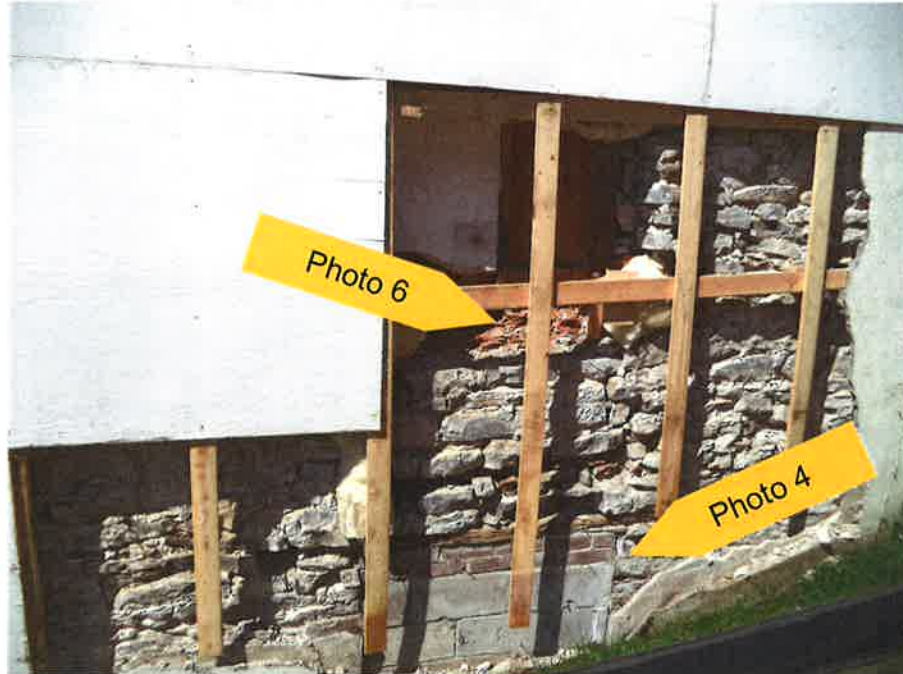
3 Close-up view of exposed wall section

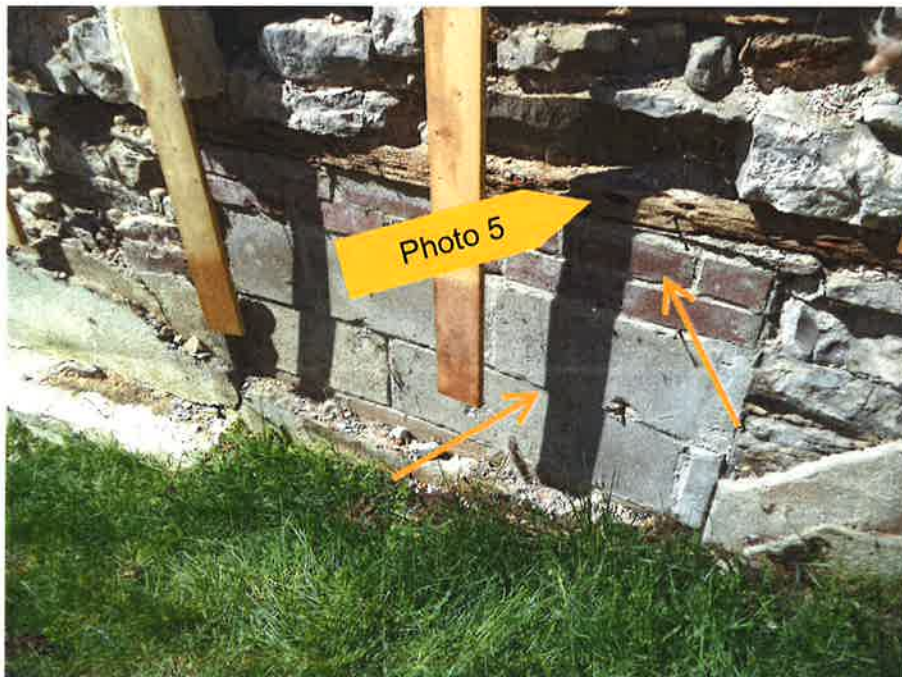
4 Note concrete block and brick infill at former basement window

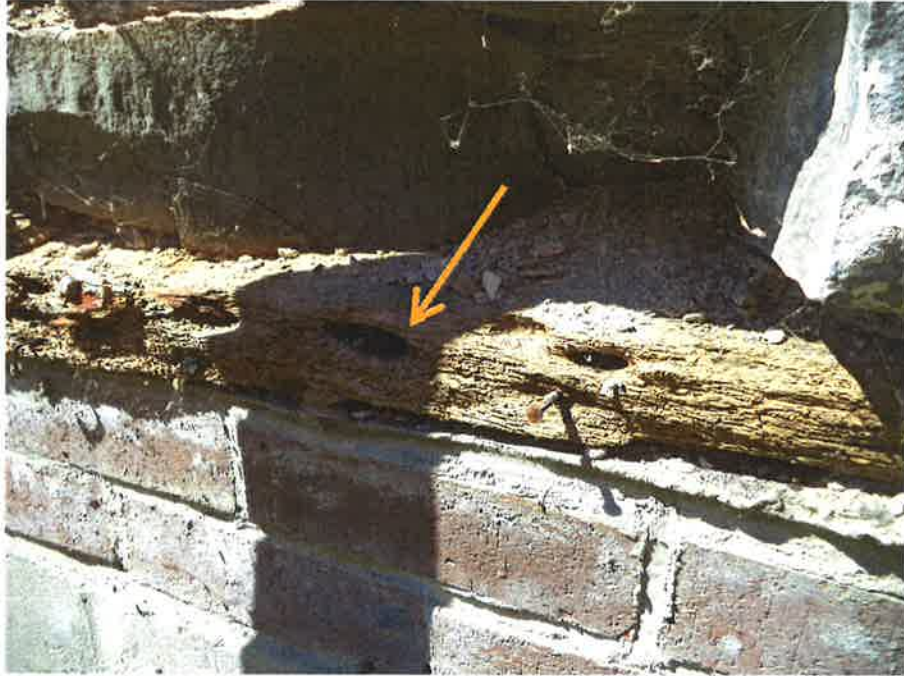
5 Close-up view of decayed wood lintel

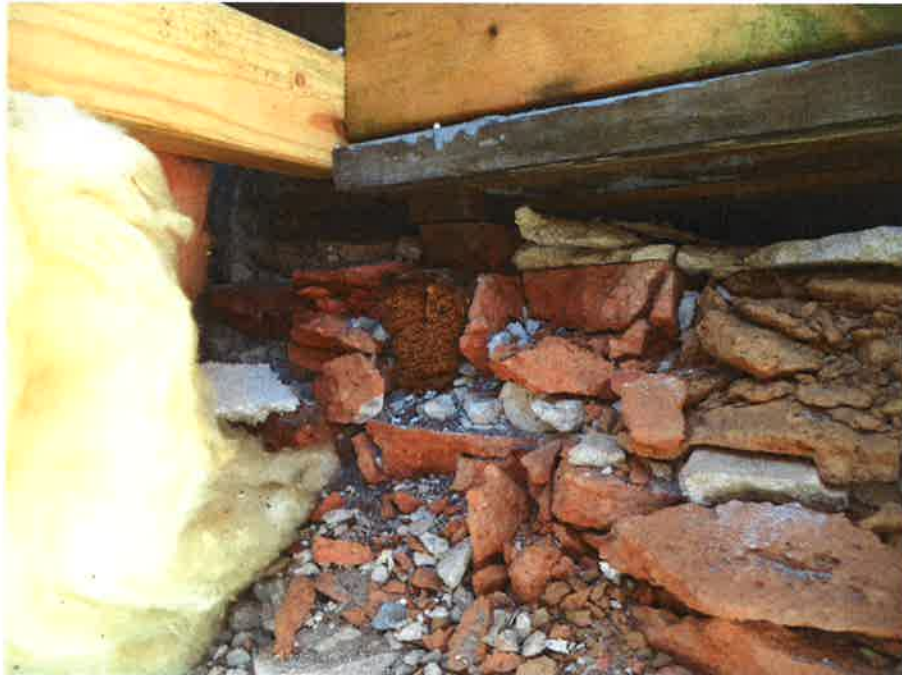
6 Close-up view of deteriorated clay brick infill below former ground floor window

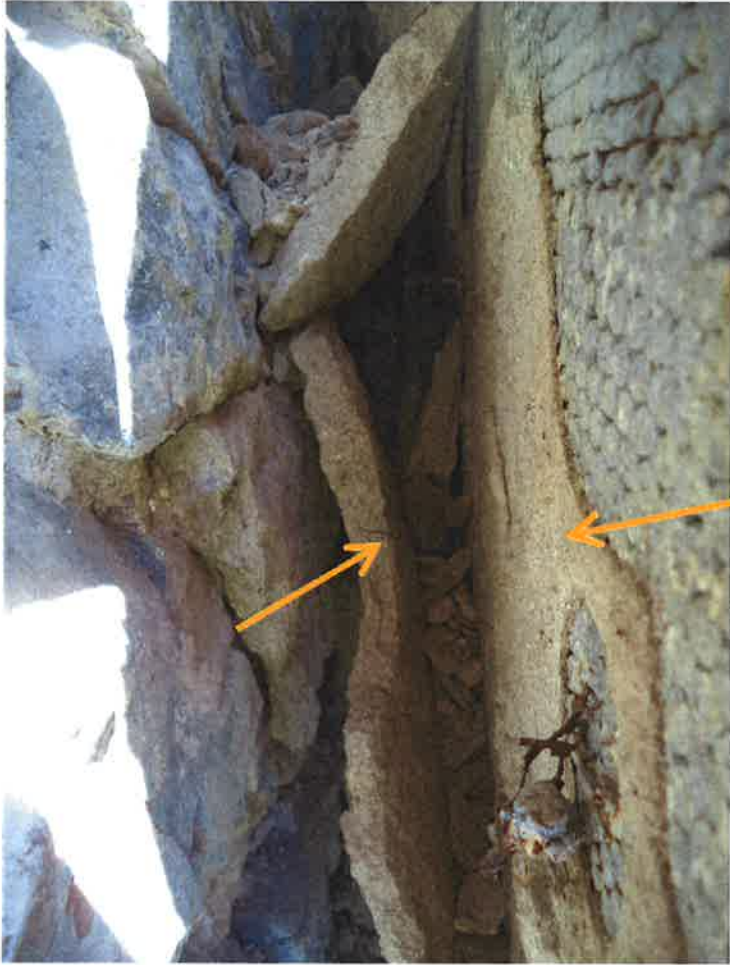
At the inspection opening on the east wall, we noticed that large areas of the stucco have separated from the stone masonry wall and, interestingly, we noticed the presence of two layers of stucco which had separated from each other (Photo 7).

7 Showing presence of existing double layer of stucco on east wall

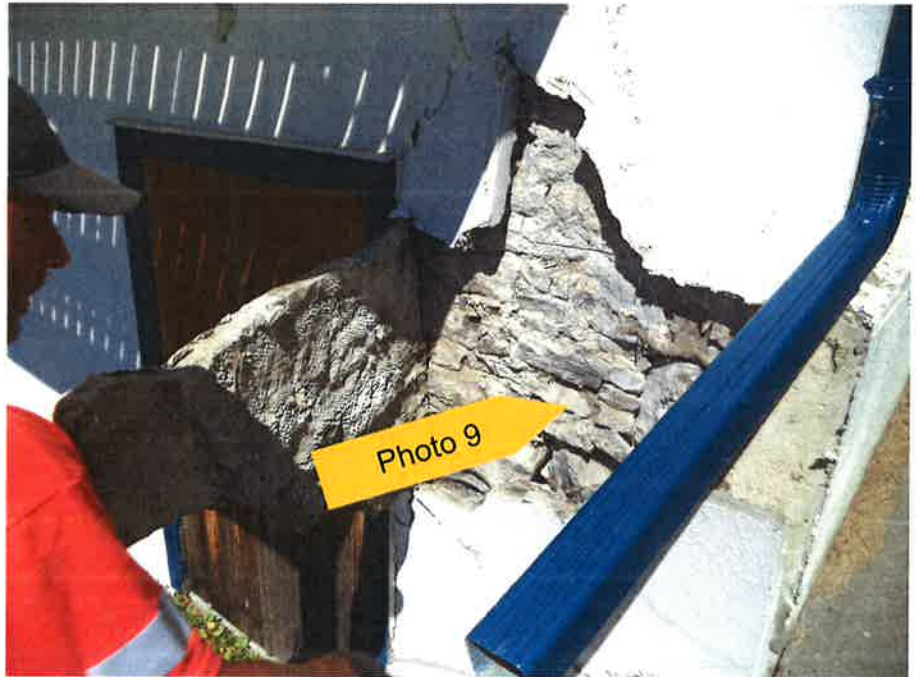
8 View of exposed masonry at SE corner

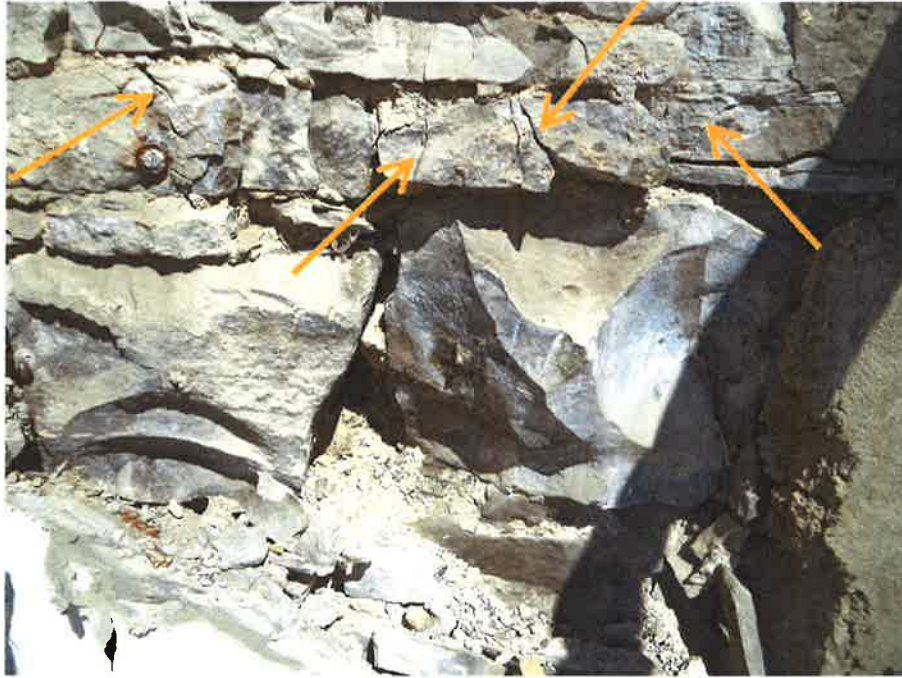
Pertaining to the condition of the stone masonry walls, based on the exposed wall section on the east wall and the SE corner, we found that many stone units were cracked and the mortar was loose and of a sandy consistency (Photo 9). While it is not possible to judge the condition of all exterior walls based solely on these very limited viewing areas, it is nevertheless possible that all exterior wall surfaces are in a similar state of disrepair. In contrast, the exposed masonry walls in the basement are in excellent condition.

The exterior wythe of the stone masonry walls of the Forwarders' Museum appears to be in disrepair caused primarily by freeze/thaw action in the presence of moisture. The full extent of the deterioration is not known at this time. It would appear that the stucco on the exterior was installed at a later date primarily to protect the walls against moisture penetration and general deterioration.

9 Close-up view showing numerous fractures in stone units and poor mortar condition

Based on our cursory inspection, we are of the opinion that the massive stone masonry walls of the Forwarders' Museum can be remediated with the repointing and partial reconstruction of the exterior masonry wythe. If foundation movements are occurring due to frost heaving or poor and variable soils conditions, as determined through a geotechnical investigation, these movements should be arrested first before the masonry walls are restored. The costs of these repairs can only be estimated reliably once the aforementioned key questions have been answered.

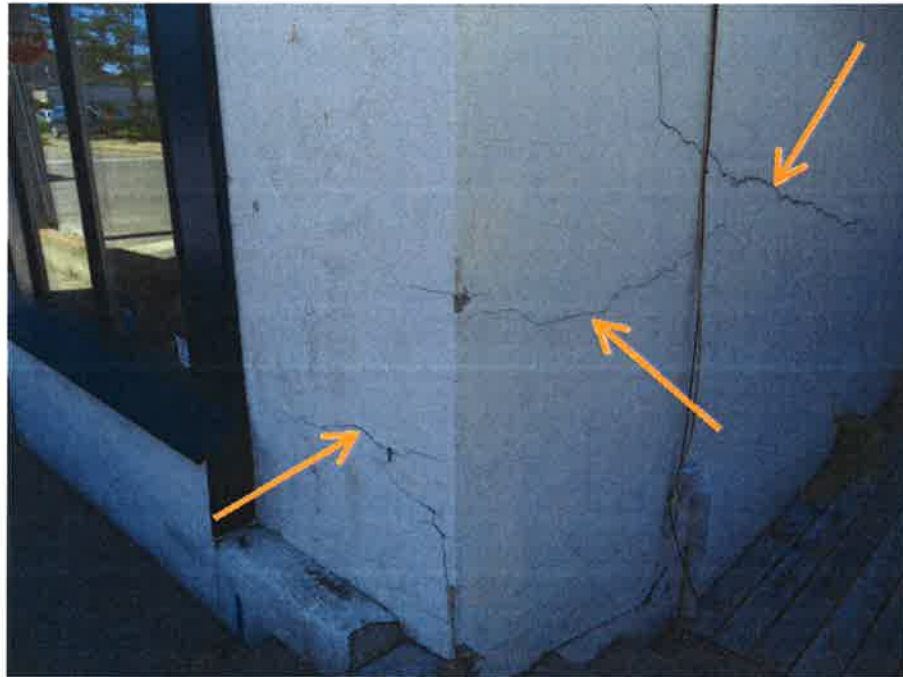
10 Showing miscellaneous cracking in stucco at NW corner

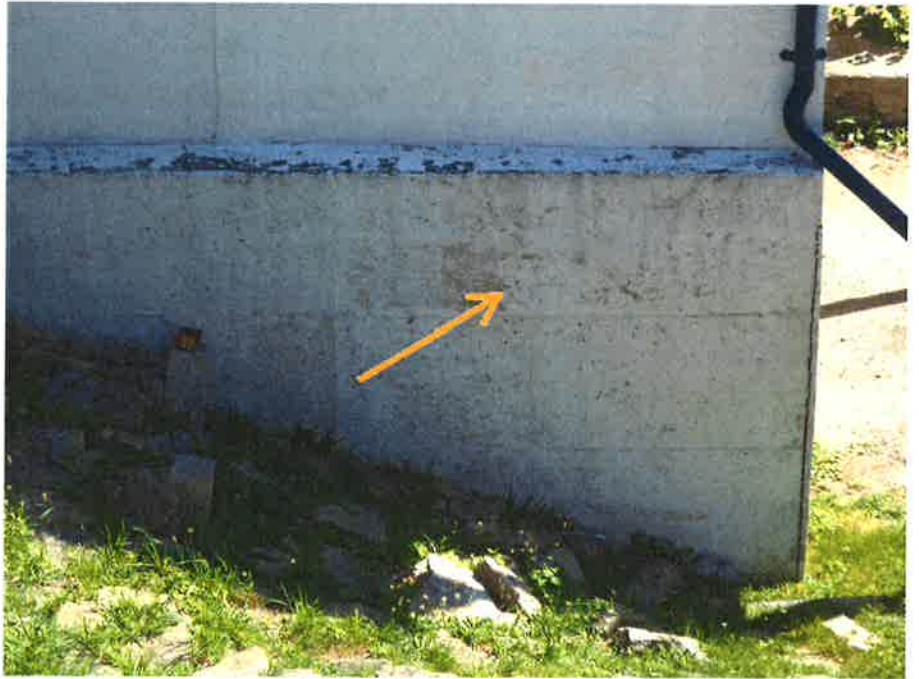
11 View of concrete foundation wall strengthening measures carried out in 1977

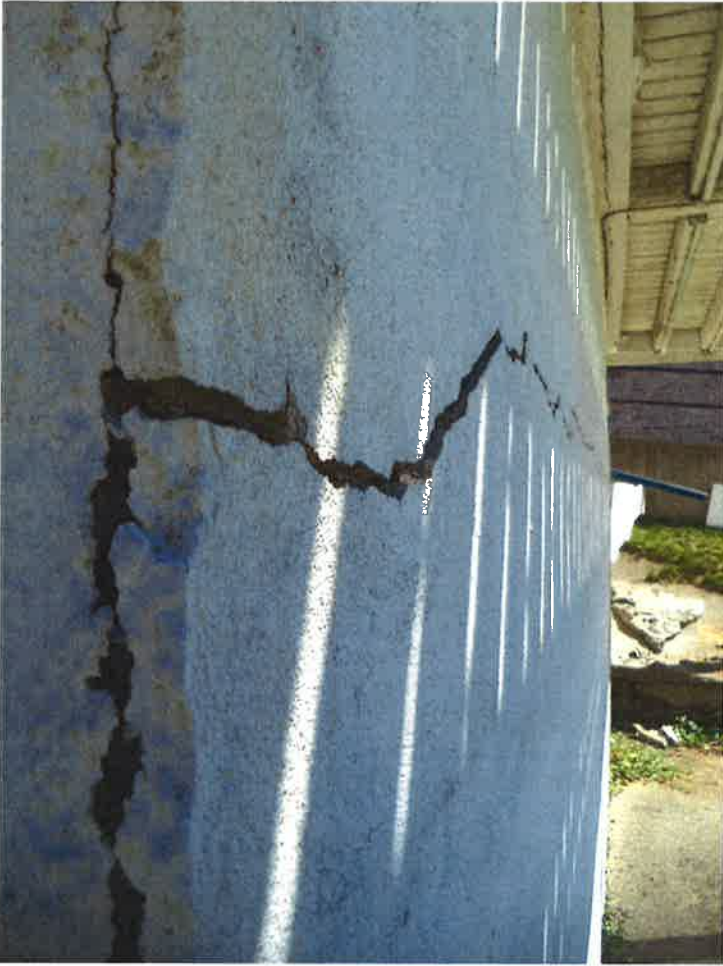
- 13 Close-up view showing horizontal crack and delamination of stucco at SW corner

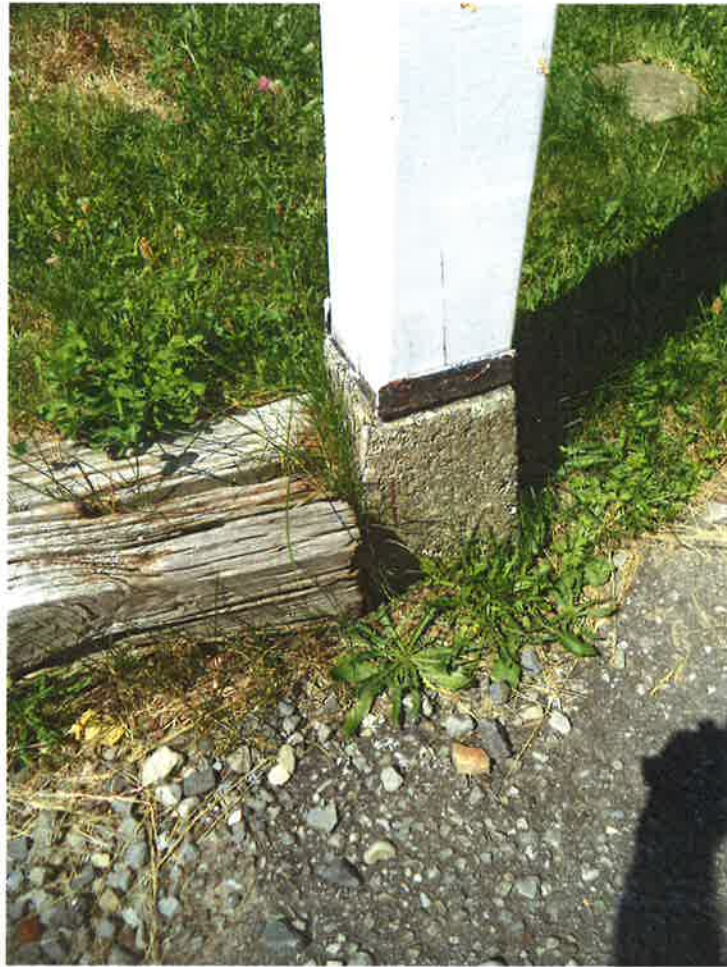
The wood balcony structure has been strengthened some time ago and it appears to be solid when walked on. It appears that the balcony structure is pulling away from the building which is likely caused by frost heaving of the concrete piers (Photo 15).

15 Typical balcony post support detail

An engineering review of the balcony should also be carried out to determine whether it meets OBC requirements for public access. In the interim, the balcony should be closed to the public.
