**STONE MASONRY WALL
STRUCTURAL REVIEW
OF
FORWARDERS' MUSEUM
PRESCOTT, ONTARIO**

REPORT PREPARED FOR
Mr. Dan Beattie
Town of Prescott
360 Dibble Street West
Prescott, Ontario
K0E 1T0

OTTAWA, ONTARIO
July 19, 2018

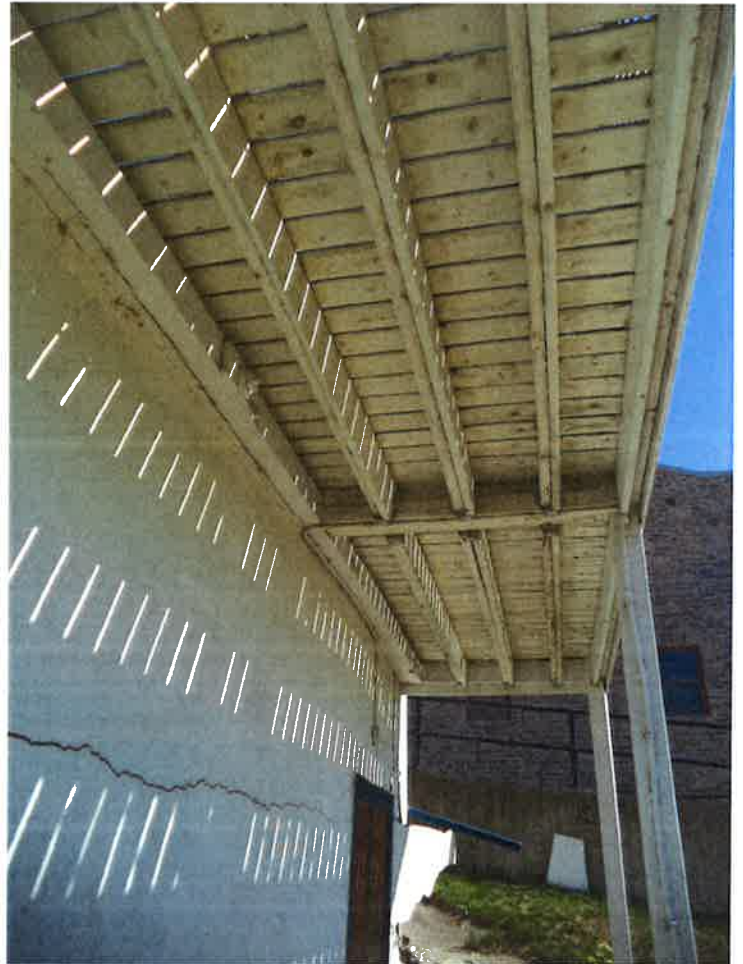
The wood balcony structure has been strengthened some time ago and it appears to be solid when walked on. It appears that the balcony structure is pulling away from the building which is likely caused by frost heaving of the concrete piers (Photo 15).

15 Typical balcony post support detail
